**Flood Control Project Maintenance  
Levee Inspections**

## Maintenance Issue Types Only, Levee Inspection Report By Mile - Spring 2016

### Reclamation District No. 0563 Tyler Island

Waterway	Bank	Unit Miles	Inspection Start/End	Inspector
Unit No. 01 Georgiana Slough (Tyler Island)	Left	12.11	03/28/2016 03/28/2016	Richard Willoughby

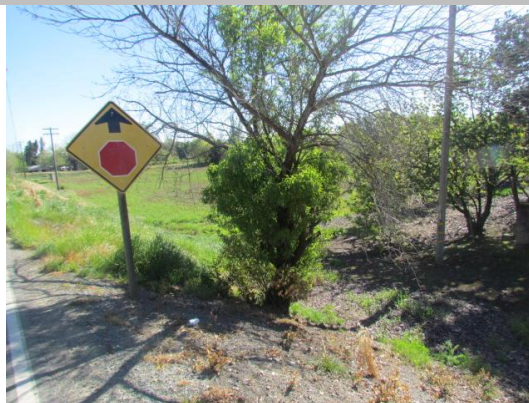
Photo 1 of 1 : SP\_2016\_RD0563\_210\_59\_20160330\_00227.jpg

LM Start	0.10	Rating **	M	Issue No.	59
LM End	0.10	Issue Type +	Ma	Location *	LS
Category	Earthen Levee			GPS Latitude/Longitude	
				Start	End
Item	Trim / Thin Trees			38.234113 °	38.234113 °
				-121.518467 °	-121.518467 °
DWR ID	DWR_RD0563_01_s _ 2013_59				
Comment Code					
T1 : Trim trees to at least five feet above ground level.					
Inspector Comment					
Dead tree should be removed.

Looking northeast at dead tree on landward slope.

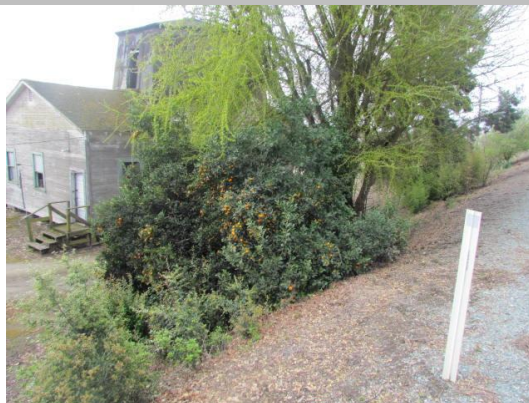
Photo 2 of 2 : SP\_2016\_RD0563\_210\_28\_20160308\_00030.jpg

LM Start	0.12	Rating **	A/W	Issue No.	28 (cont)	
LM End	0.14	Issue Type +	Ma	Location *	LS	
Category	Earthen Levee			GPS Latitude/Longitude		
				Start		End
Item	Trim / Thin Trees			38.233910 °		38.233655 °
				-121.518722 °		-121.519000 °
DWR ID	DWR_RD0563_01_s _ 2012_28					
Comment Code						
T1 : Trim trees to at least five feet above ground level.						
Inspector Comment

Looking southeast at landscaping on landside slope and toe.

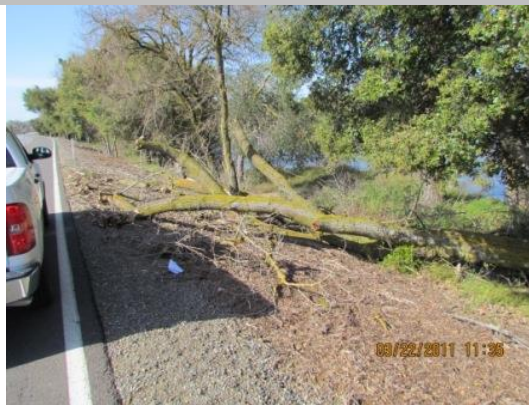
Photo 1 of 1 : SP\_2016\_RD0563\_210\_32\_20160308\_00033.jpg

LM Start	0.17	Rating **	M	Issue No.	32
LM End	0.17	Issue Type +	Ma	Location *	WS
Category	Earthen Levee			GPS Latitude/Longitude	
				Start	End
Item	Encroachments			38.233315 °	38.233315 °
				-121.519360 °	-121.519360 °
DWR ID	DWR_RD0563_01_s _ 2012_32				
Comment Code					
TR : Tree or limb					
Inspector Comment					
Tree fallen across waterward slope.

Looking south (downstream) at fallen tree limb on waterside slope.

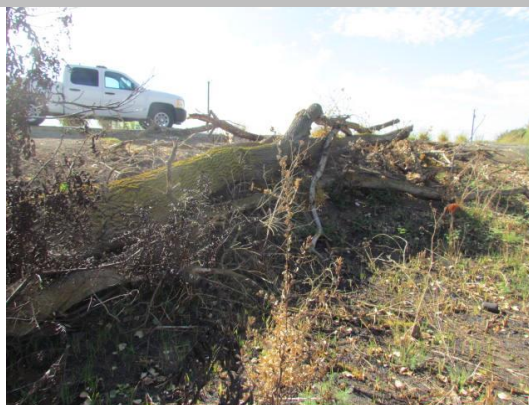
Photo 1 of 5 : SP\_2016\_RD0563\_210\_139\_20160308\_00120.jpg

LM Start	0.60	Rating **	U	Issue No.	139
LM End	0.60	Issue Type +	Ma	Location *	WS
Category	Earthen Levee			GPS Latitude/Longitude	
				Start	End
Item	Encroachments			38.228605 °	38.228605 °
				-121.524364 °	-121.524364 °
DWR ID	DWR_RD0563_01_f_2015_139				
Comment Code					
TR : Tree or limb					
Inspector Comment					
Large fallen tree on waterward slope. Fallen tree left large hole on waterward berm.

Looking southeast at fallen tree on waterward slope.

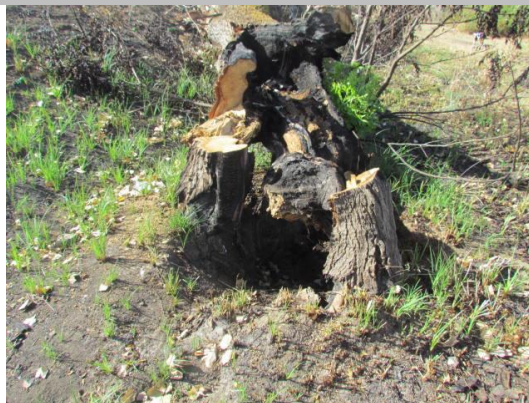
Photo 3 of 5 : SP\_2016\_RD0563\_210\_139\_20160308\_00122.jpg

LM Start	0.60	Rating **	U	Issue No.	139 (cont)	
LM End	0.60	Issue Type +	Ma	Location *	WS	
Category	Earthen Levee			GPS Latitude/Longitude		
				Start		End
Item	Encroachments			38.228605 °	38.228605 °	
				-121.524364 °	-121.524364 °	
DWR ID	DWR_RD0563_01_f_2015_139					
Comment Code						
TR : Tree or limb						
Inspector Comment						
Large fallen tree on waterward slope. Fallen tree left large hole on waterward berm.

Looking at stump of fallen tree on waterward berm.

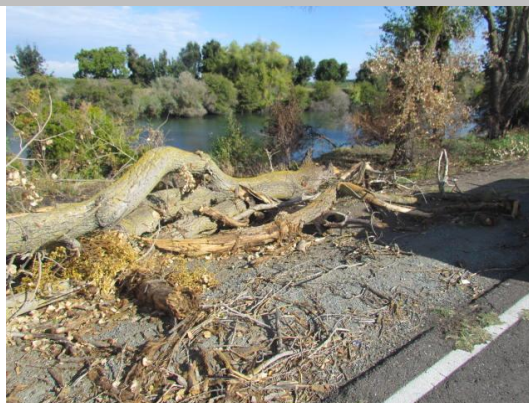
Photo 4 of 5 : SP\_2016\_RD0563\_210\_139\_20160308\_00123.jpg

Looking northwest at fallen tree on waterward slope.

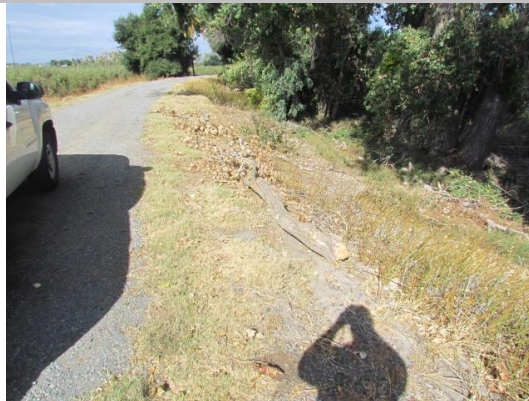
Photo 1 of 1 : SP\_2016\_RD0563\_210\_144\_20160308\_00131.jpg

LM Start	0.89	Rating **	M	Issue No.	144
LM End	0.89	Issue Type +	Ma	Location *	WS
Category	Earthen Levee			GPS Latitude/Longitude	
				Start	End
Item	Encroachments			38.225477 °	38.225477 °
				-121.527047 °	-121.527047 °
DWR ID	DWR_RD0563_01_f_2014_144				
Comment Code					
PR : Prunings					
Inspector Comment					
Tree limbs on waterward slope.

Looking at tree limbs on waterward shoulder and slope.

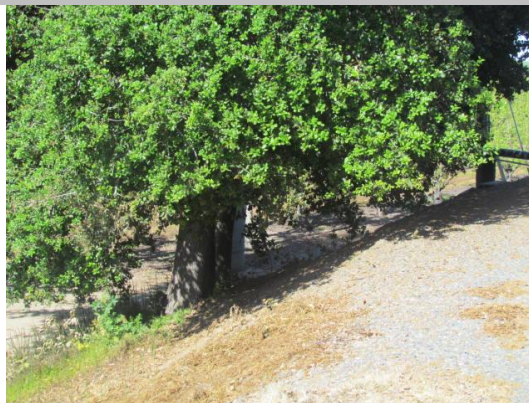
Photo 1 of 1 : SP\_2016\_RD0563\_210\_755\_20160330\_00229.jpg

LM Start	0.92	Rating **	U	Issue No.	755
LM End	0.92	Issue Type +	Ma	Location *	LS
Category	Earthen Levee			GPS Latitude/Longitude	
				Start	End
Item	Trim / Thin Trees			38.225549 °	38.225549 °
				-121.527658 °	-121.527658 °
DWR ID	DWR_RD0563_01_s_2015_755				
Comment Code					
T1 : Trim trees to at least five feet above ground level.					
Inspector Comment

Looking southeast at untrimmed tree on landward slope.

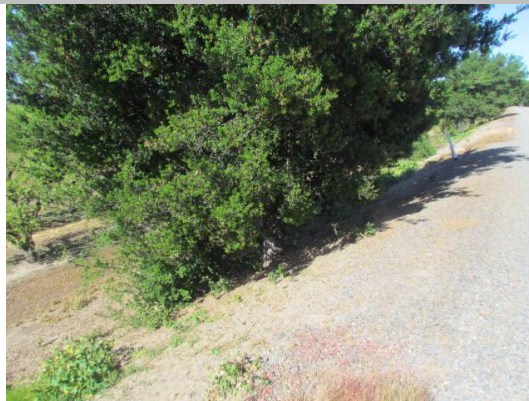
Photo 1 of 1 : SP\_2016\_RD0563\_210\_756\_20160330\_00230.jpg

LM Start	0.98	Rating **	U	Issue No.	756
LM End	0.98	Issue Type +	Ma	Location *	LS
Category	Earthen Levee			GPS Latitude/Longitude	
				Start	End
Item	Trim / Thin Trees			38.226011 °	38.226011 °
				-121.528524 °	-121.528524 °
DWR ID	DWR_RD0563_01_s_2015_756				
Comment Code					
T1 : Trim trees to at least five feet above ground level.					
Inspector Comment

Looking southeast at untrimmed tree on landward slope.

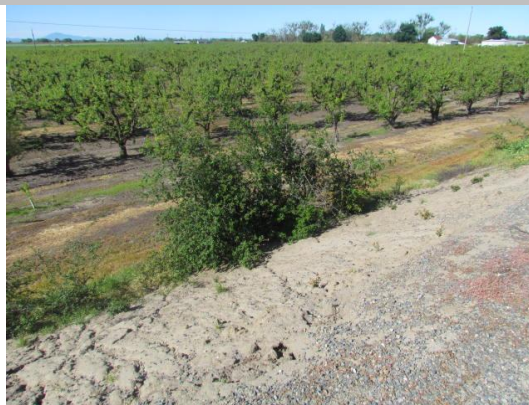
Photo 1 of 1 : SP\_2016\_RD0563\_210\_132\_20160330\_00231.jpg

LM Start	0.99	Rating **	M	Issue No.	132
LM End	0.99	Issue Type +	Ma	Location *	LS
Category	Earthen Levee			GPS Latitude/Longitude	
				Start	End
Item	Trim / Thin Trees			38.226149 °	38.226149 °
				-121.528789 °	-121.528789 °
DWR ID	DWR_RD0563_01_s_2016_132				
Comment Code					
T1 : Trim trees to at least five feet above ground level.					
Inspector Comment					
Small trees on landward shoulder be removed.

Looking southeast at several small trees at landward toe.

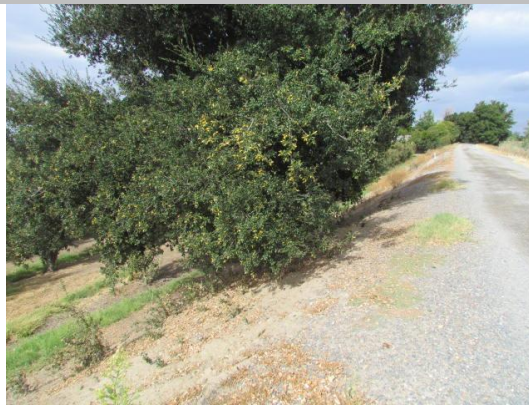
Photo 1 of 1 : SP\_2016\_RD0563\_210\_757\_20160308\_00140.jpg

LM Start	1.01	Rating **	M	Issue No.	757
LM End	1.01	Issue Type +	Ma	Location *	LS
Category	Earthen Levee			GPS Latitude/Longitude	
				Start	End
Item	Trim / Thin Trees			38.226294 °	38.226294 °
				-121.529055 °	-121.529055 °
DWR ID	DWR_RD0563_01_s_2015_757				
Comment Code					
T1 : Trim trees to at least five feet above ground level.					
Inspector Comment

Looking at untrimmed trees on landward slope.

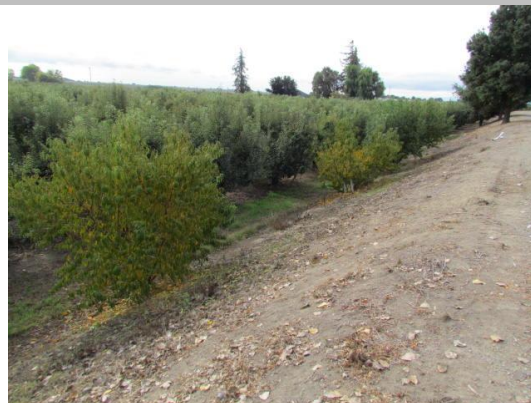
Photo 1 of 1 : SP\_2016\_RD0563\_210\_64\_20160308\_00059.jpg

LM Start	1.27	Rating **	M	Issue No.	64	
LM End	1.27	Issue Type +	Ma	Location *	LS	
Category	Earthen Levee			GPS Latitude/Longitude		
				Start		End
Item	Trim / Thin Trees			38.225730 °		38.225730 °
				-121.532824 °		-121.532824 °
DWR ID	DWR_RD0563_01_f_2012_64					
Comment Code						
T1 : Trim trees to at least five feet above ground level.						
Inspector Comment						
Trees located at landside toe.

Looking southeast at fruit trees on landside toe.

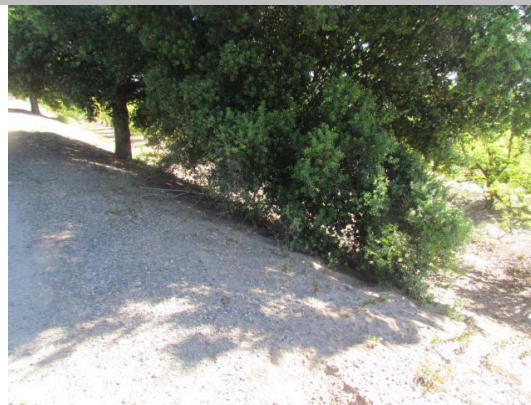
Photo 1 of 1 : SP\_2016\_RD0563\_210\_79\_20160330\_00235.jpg

LM Start	1.32	Rating **	U	Issue No.	79
LM End	1.32	Issue Type +	Ma	Location *	LS
Category	Earthen Levee			GPS Latitude/Longitude	
				Start	End
Item	Trim / Thin Trees			38.225177 °	38.225177 °
				-121.533285 °	-121.533285 °
DWR ID	DWR_RD0563_01_f_2013_79				
Comment Code					
T1 : Trim trees to at least five feet above ground level.					
Inspector Comment

Looking northeast at untrimmed trees on landward slope and toe.

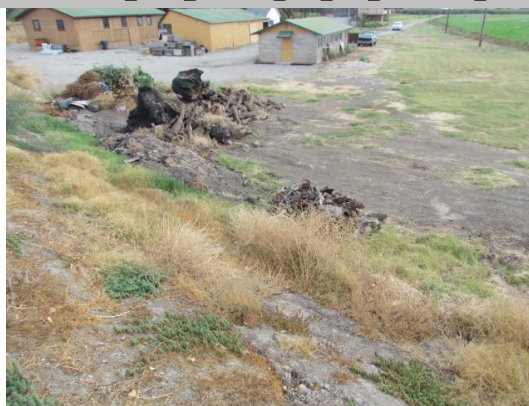
Photo 1 of 1 : SP\_2016\_RD0563\_210\_157\_20160308\_00136.jpg

LM Start	1.94	Rating **	A/W	Issue No.	157
LM End	1.94	Issue Type +	Ma	Location *	LS
Category	Earthen Levee			GPS Latitude/Longitude	
				Start	End
Item	Encroachments			38.222080 °	38.222080 °
				-121.543445 °	-121.543445 °
DWR ID	DWR_RD0563_01_f_2015_157				
Comment Code					
GA : Garbage					
Inspector Comment					
Landowner stockpiling garbage at landward toe.

Looking at garbage stockpile at landward toe.

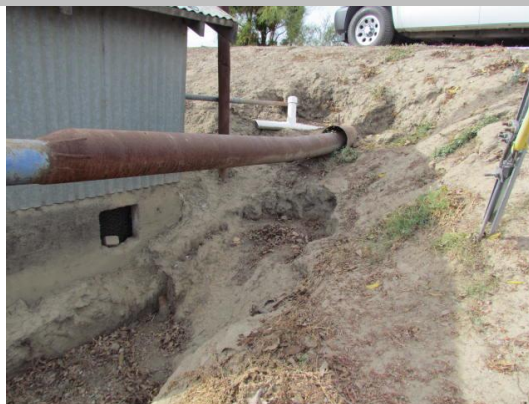
Photo 1 of 2 : SP\_2016\_RD0563\_210\_71\_20160308\_00063.jpg

LM Start	1.95	Rating **	M	Issue No.	71
LM End	1.95	Issue Type +	Ma	Location *	LS
Category	Earthen Levee			GPS Latitude/Longitude	
				Start	End
Item	Erosion / Bank Caving			38.221826 °	38.221826 °
				-121.543467 °	-121.543467 °
DWR ID	DWR_RD0563_01_f_2012_71				
Comment Code					
E1 : Note and monitor erosion site.					
Inspector Comment					
Erosion around irrigation pump house and pipe on landside slope.

Looking west at erosion at landside toe and slope next to pump house.

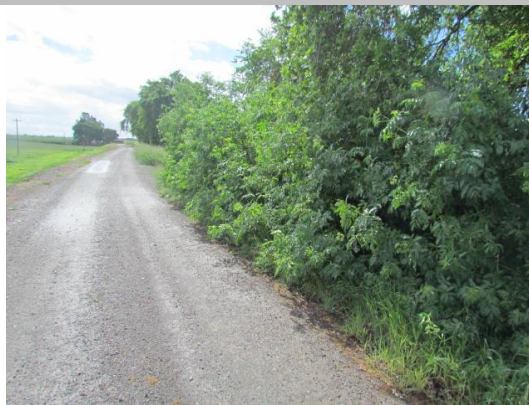
Photo 1 of 2 : SP\_2016\_RD0563\_210\_12\_20160308\_00016.jpg

LM Start	2.40	Rating **	U	Issue No.	12
LM End	2.41	Issue Type +	Ma	Location *	WS
Category	Earthen Levee			GPS Latitude/Longitude	
				Start	End
Item	Vegetation			38.216122 °	38.216047 °
				-121.540555 °	-121.540415 °
DWR ID	DWR_RD0563_01_s_2012_12				
Comment Code					
V4 : Elderberries are blocking visibility and flood fight capability.					
Inspector Comment

Looking south at dense elderberry on waterward shoulder and slope.  
(Spring 2015)

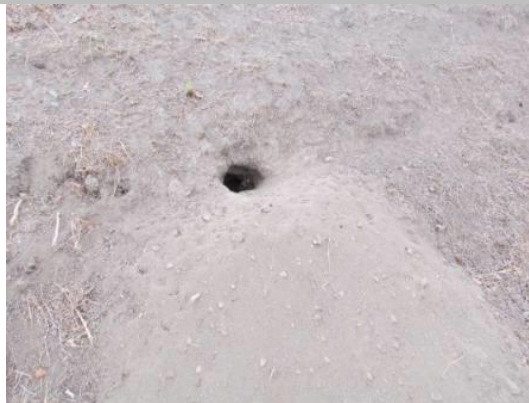
Photo 1 of 4 : SP\_2016\_RD0563\_210\_85\_20160308\_00087.jpg

LM Start	2.53	Rating **	M	Issue No.	85
LM End	2.55	Issue Type +	Ma	Location *	LS
Category	Earthen Levee			GPS Latitude/Longitude	
				Start	End
Item	Animal Control			38.215082 °	38.214852 °
				-121.538652 °	-121.538305 °
DWR ID	DWR_RD0563_01_s_2012_85				
Comment Code					
A3 : No rodents visible, but rodent burrows visible; need to backfill and compact or grout burrows.					
Inspector Comment

Looking west at rodent hole on landside slope.

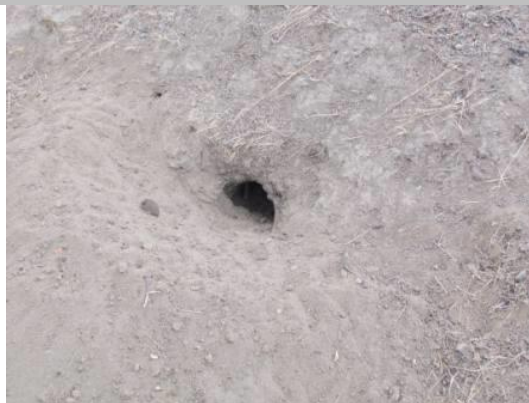
Photo 2 of 4 : SP\_2016\_RD0563\_210\_85\_20160308\_00088.jpg

Looking east at rodent hole on landside slope.

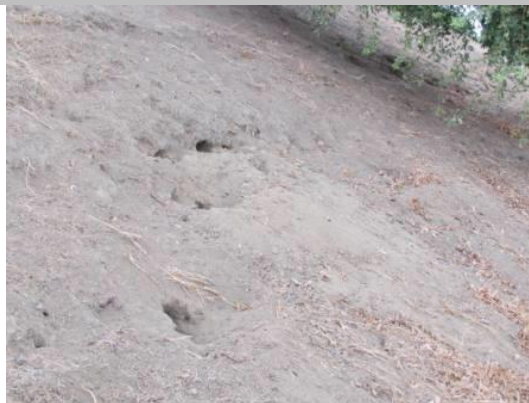
Photo 4 of 4 : SP\_2016\_RD0563\_210\_85\_20160308\_00090.jpg

LM Start	2.53	Rating **	M	Issue No.	85 (cont)	
LM End	2.55	Issue Type +	Ma	Location *	LS	
Category	Earthen Levee			GPS Latitude/Longitude		
				Start		End
Item	Animal Control			38.215082 °		38.214852 °
				-121.538652 °		-121.538305 °
DWR ID	DWR_RD0563_01_s _ 2012_85					
Comment Code						
A3 : No rodents visible, but rodent burrows visible; need to backfill and compact or grout burrows.						
Inspector Comment

Looking northeast at rodent holes on landside slope.

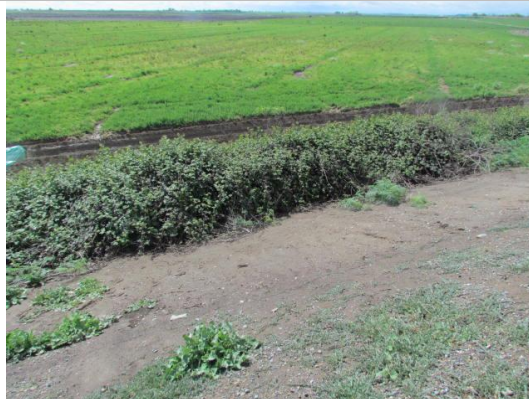
Photo 1 of 1 : SP\_2016\_RD0563\_210\_67\_20160308\_00060.jpg

LM Start	2.94	Rating **	M	Issue No.	67
LM End	2.94	Issue Type +	Ma	Location *	LS
Category	Earthen Levee			GPS Latitude/Longitude	
				Start	End
Item	Vegetation			38.210402 °	38.210402 °
				-121.535268 °	-121.535268 °
DWR ID	DWR_RD0563_01_s_2012_67				
Comment Code					
V2 : Remove the wild growth other than native grasses from the levee slopes.					
Inspector Comment					
Vines (Berry or wildroses) on landside toe.

Looking east at dense vegetation at landward toe.

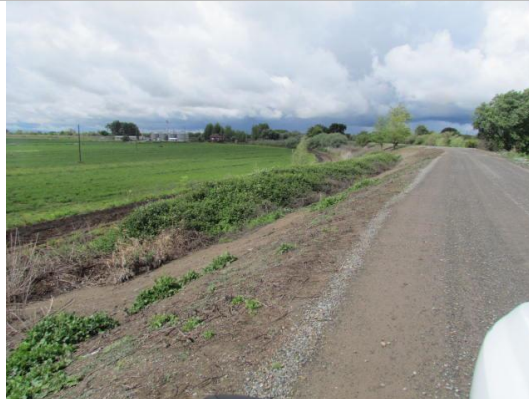
Photo 2 of 4 : SP\_2016\_RD0563\_210\_74\_20160308\_00067.jpg

LM Start	3.02	Rating **	U	Issue No.	74
LM End	3.21	Issue Type +	Ma	Location *	LS
Category	Earthen Levee			GPS Latitude/Longitude	
				Start	End
Item	Vegetation			38.210212 °	38.209165 °
				-121.536728 °	-121.539920 °
DWR ID	DWR_RD0563_01_s_2012_74				
Comment Code					
V2 : Remove the wild growth other than native grasses from the levee slopes.					
Inspector Comment					
Dead berryvines at landside toe blocking view of toe.

Looking southeast at dense berryvines at landward toe. (Spring 2015)

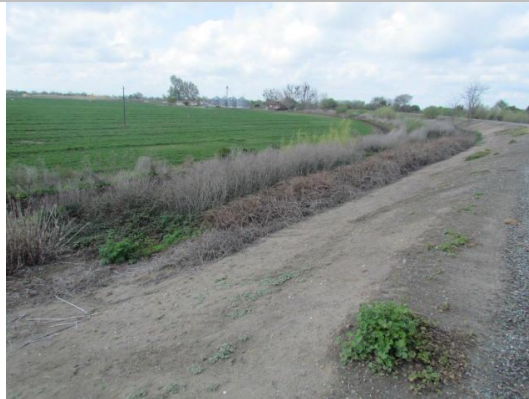
Photo 3 of 4 : SP\_2016\_RD0563\_210\_74\_20160308\_00068.jpg

Looking southeast at dead berryvine on landside toe. (Fall 2014)

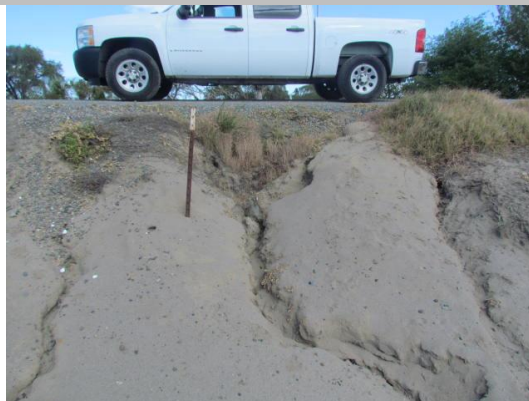
Photo 1 of 5 : SP\_2016\_RD0563\_210\_78\_20160330\_00247.jpg

Looking west at finger erosion on landward slope. (Spring 2016)

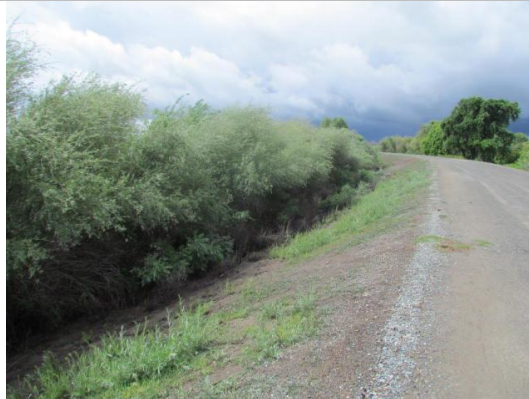
Photo 2 of 2 : SP\_2016\_RD0563\_210\_763\_20160308\_00141.jpg

LM Start	3.11	Rating **	U	Issue No.	763 (cont)	
LM End	3.21	Issue Type +	Ma	Location *	LS	
Category	Earthen Levee			GPS Latitude/Longitude		
				Start		End
Item	Vegetation			38.210005 °		38.209229 °
				-121.538452 °		-121.539855 °
DWR ID	DWR_RD0563_01_s_2015_763					
Comment Code						
V2 : Remove the wild growth other than native grasses from the levee slopes.						
Inspector Comment						
Dense vegetation (willows) at landward toe.

Looking south at dense vegetation at landward slope and toe. (Spring 2015)

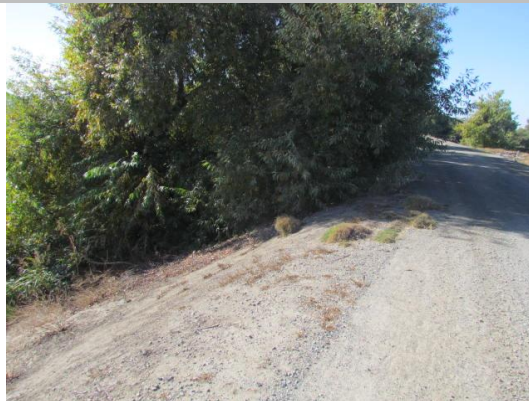
Photo 1 of 2 : SP\_2016\_RD0563\_210\_68\_20160308\_00061.jpg

LM Start	3.21	Rating **	U	Issue No.	68
LM End	3.21	Issue Type +	Ma	Location *	LS
Category	Earthen Levee			GPS Latitude/Longitude	
				Start	End
Item	Trim / Thin Trees			38.209217 °	38.209217 °
				-121.539823 °	-121.539823 °
DWR ID	DWR_RD0563_01_s_2012_68				
Comment Code					
T2 : Thin trees to allow visibility of the ground and room to flood fight.					
Inspector Comment

Looking south at dense trees on landward slope.

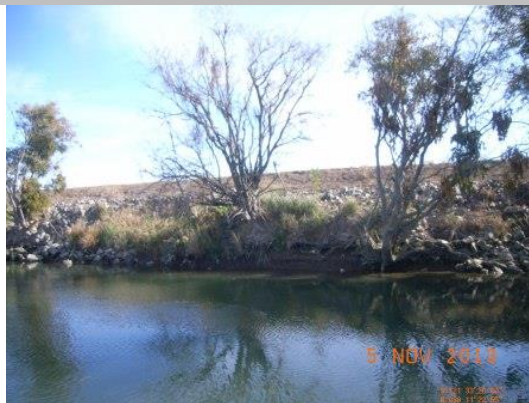
Photo 1 of 1 : SP\_2016\_RD0563\_210\_38\_20160308\_00037.jpg

LM Start	3.91	Rating **	M	Issue No.	38
LM End	4.01	Issue Type +	Ma	Location *	WS
Category	Supplemental			GPS Latitude/Longitude	
				Start	End
Item	2015 USACE Erosion Survey, DRAFT			38.200733 °	38.199925 °
				-121.542571 °	-121.544249 °
DWR ID	DWR_RD0563_01_s_2016_38				
Comment Code					
Inspector Comment					
1997 - Narrow eroding berm upstream of existing rock. 2001 - Staked, low fascine walls at bankline. 2011 - Minor new erosion. Site extended downstream. 2012 - Rock repair failing in one erosion pocket. 2015: Last observed in 2013. [2015 Site ID: GEO_8-3_L]

USACE 2013 Photo #1

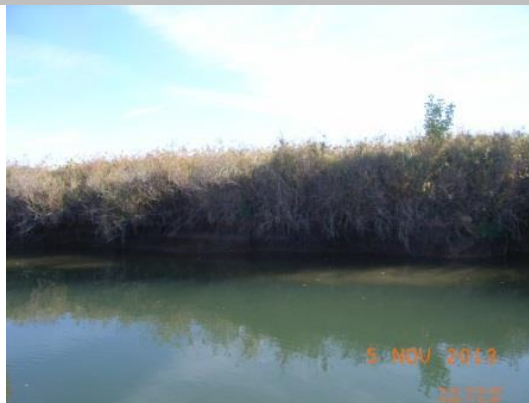
Photo 1 of 1 : SP\_2016\_RD0563\_210\_45\_20160308\_00044.jpg

LM Start	4.98	Rating **	M	Issue No.	45
LM End	5.04	Issue Type +	Ma	Location *	WS
Category	Supplemental			GPS Latitude/Longitude	
				Start	End
Item	2015 USACE Erosion Survey, DRAFT			38.190073 °	38.189524 °
				-121.556307 °	-121.557227 °
DWR ID	DWR_RD0563_01_s_2016_45				
Comment Code					
Inspector Comment					
2009 - Small scallops of erosion into the levee toe behind brush boxes. 2011 - Minor new erosion. 2012 - Site extended upstream to account for addition erosion pockets. 2015: Last observed in 2013. [2015 Site ID: GEO_7-2_L]

USACE 2013 Photo #1

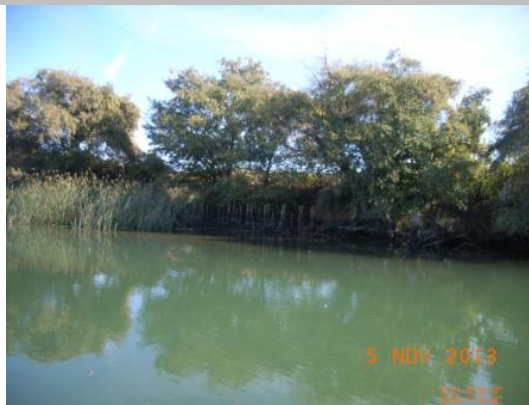
Photo 1 of 1 : SP\_2016\_RD0563\_210\_46\_20160308\_00045.jpg

LM Start	5.15	Rating **	U	Issue No.	46
LM End	5.39	Issue Type +	Ma	Location *	WS
Category	Supplemental			GPS Latitude/Longitude	
				Start	End
Item	2015 USACE Erosion Survey, DRAFT			38.188216 °	38.185968 °
				-121.558442 °	-121.561667 °
DWR ID	DWR_RD0563_01_s_2016_46				
Comment Code					
Inspector Comment					
1997 - Deep pockets of erosion into a narrow berm just downstream of the rock. 2000 - Scallops in banks with small colored flags, some new biotech rolls in with older rolls in the scallops. 2001 - Staked , low fascine walls at the bankline. 2011 - Site upgraded to CRITICAL. Site extended upstream due to new erosion pocket. New tree popouts and new erosion. 2013 - Pipe observed at upstream end of site. 2015: Last observed in 2013. [2015 Site ID: GEO_6-8_L]

USACE 2013 Photo #1

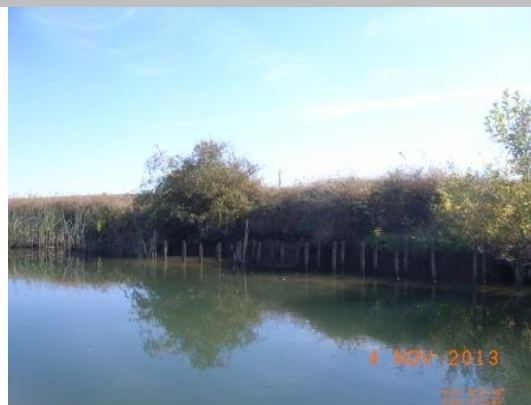
Photo 1 of 1 : SP\_2016\_RD0563\_210\_55\_20160308\_00053.jpg

Comment Code					
Inspector Comment					
1997 - Deep pockets of erosion and narrow berm. Reach is characterized by lots of pockets into the existing berm and/or levee slope. 1999 - Some pockets filled with rock riprap. 2000 - Exposed fabric. 2001 - Staked, low fascine walls at bankline. 2002 - New spot of rock at upstream end. Some new brush boxes. 2005 - Some stone sliding off the underlying geotextile fabric. Some new brush bundles in the brush boxes; some with missing bundles. Some boxes too low relative to high tide. 2009 - Minimal new erosion, site length extended. 2010 - New erosion on downstream end, site extended downstream. 2011 - Sites 6.1, 6.4 and 6.6 were combined. New erosion pockets, site extended to include the erosion in between the old sites. 2012 - Rock has been placed in portions of the bank since last year. 2015: Last observed in 2013. [2015 Site ID: GEO_6-3_L]

USACE 2013 Photo #1

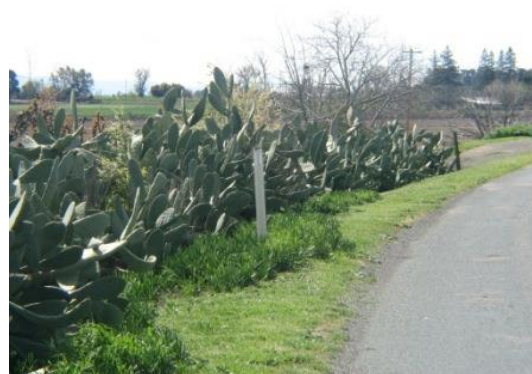
Photo 2 of 2 : SP\_2016\_RD0563\_210\_22\_20160308\_00024.jpg

Large cactus plant on landward slope from LM 6.04 to 6.08

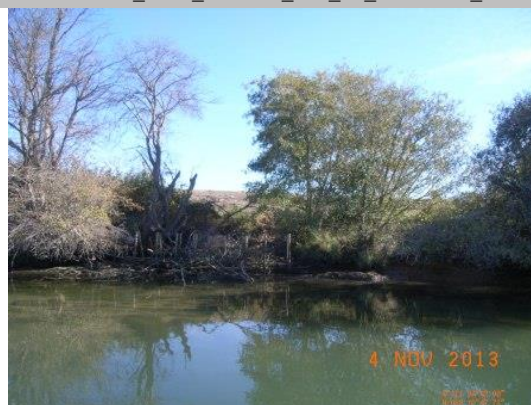
Photo 1 of 1 : SP\_2016\_RD0563\_210\_44\_20160308\_00043.jpg

LM Start	6.38	Rating **	M	Issue No.	44
LM End	6.46	Issue Type +	Ma	Location *	WS
Category	Supplemental			GPS Latitude/Longitude	
				Start	End
Item	2015 USACE Erosion Survey, DRAFT			38.180462 °	38.179319 °
				-121.577895 °	-121.578566 °
DWR ID	DWR_RD0563_01_s_2016_44				
Comment Code					
Inspector Comment					
2013 - Erosion pockets into the levee prism. Erosion pockets primarily located behind unmaintained brush boxes. 2015: Last observed in 2013. [2015 Site ID: GEO_5-8_L]

USACE 2013 Photo #1

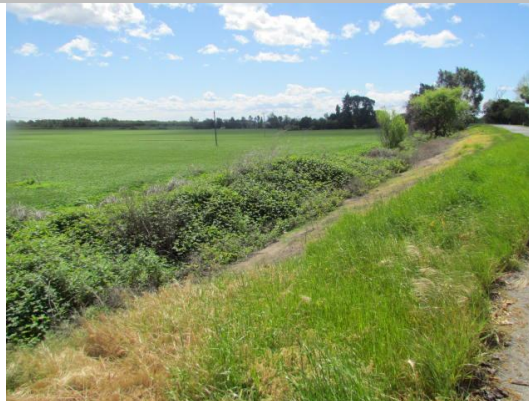
Photo 1 of 1 : SP\_2016\_RD0563\_210\_164\_20160330\_00250.jpg

LM Start	6.59	Rating **	U	Issue No.	164
LM End	6.62	Issue Type +	Ma	Location *	LS
Category	Earthen Levee			GPS Latitude/Longitude	
				Start	End
Item	Vegetation			38.177438 °	38.177033 °
				-121.579151 °	-121.579344 °
DWR ID	DWR_RD0563_01_s _ 2016_164				
Comment Code					
V2 : Remove the wild growth other than native grasses from the levee slopes.					
Inspector Comment					
Dense vegetation (vines) at landward toe.

Looking east at dense vegetation (vines) at landward toe.

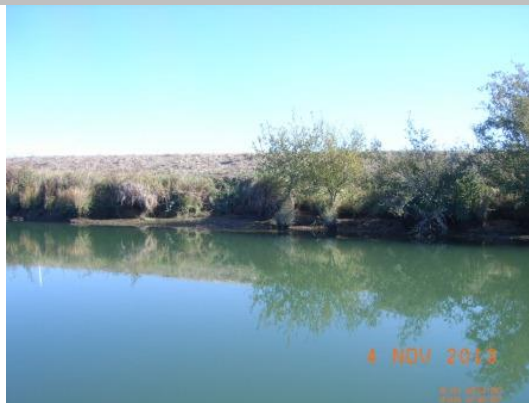
Photo 1 of 1 : SP\_2016\_RD0563\_210\_51\_20160308\_00050.jpg

LM Start	6.64	Rating **	M	Issue No.	51
LM End	7.28	Issue Type +	Ma	Location *	WS
Category	Supplemental			GPS Latitude/Longitude	
				Start	End
Item	2015 USACE Erosion Survey, DRAFT			38.176861 °	38.167959 °
				-121.579747 °	-121.581616 °
DWR ID	DWR_RD0563_01_s_2016_51				
Comment Code					
Inspector Comment					
1997 - Pocket erosion into the toe of the levee. 2000 - Scallops in banks with small colored flags, biotech rolls present. 2001 - Staked, low fascine walls at bankline. 2003 - Still have visibly bad spots, especially at the upstream end. 2005 - Some new brush bundles in the brush boxes; some with missing bundles. Some boxes too low relative to high tide. 2010 - Site extended upstream. 2011 - Minor new erosion. 2015: Last observed in 2013. [2015 Site ID: GEO 5-3 L]

USACE 2013 Photo #1

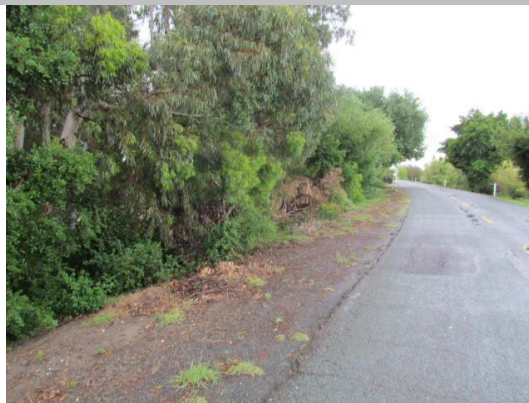
Photo 1 of 1 : SP\_2016\_RD0563\_210\_145\_20160308\_00132.jpg

LM Start	6.75	Rating **	U	Issue No.	145
LM End	6.79	Issue Type +	Ma	Location *	LS
Category	Earthen Levee			GPS Latitude/Longitude	
				Start	End
Item	Trim / Thin Trees			38.175219 °	38.174743 °
				-121.580053 °	-121.580016 °
DWR ID	DWR_RD0563_01_s_2014_145				
Comment Code					
T2 : Thin trees to allow visibility of the ground and room to flood fight.					
Inspector Comment					
Untrimmed trees blocking view of landward toe.

Looking southeast at dense vegetation on landward slope and toe.

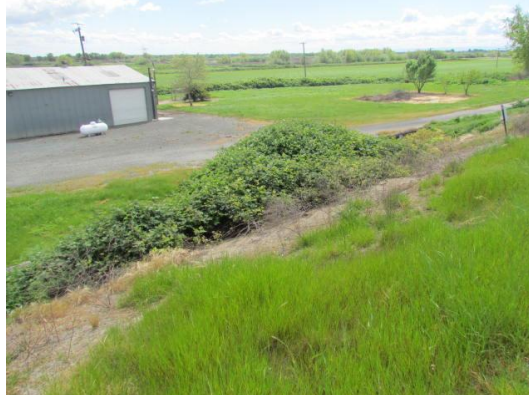
Photo 1 of 1 : SP\_2016\_RD0563\_210\_151\_20160330\_00252.jpg

LM Start	7.14	Rating **	U	Issue No.	151
LM End	7.14	Issue Type +	Ma	Location *	LS
Category	Earthen Levee			GPS Latitude/Longitude	
				Start	End
Item	Vegetation			38.169705 °	38.169705 °
				-121.580355 °	-121.580355 °
DWR ID	DWR_RD0563_01_f_2014_151				
Comment Code					
V2 : Remove the wild growth other than native grasses from the levee slopes.					
Inspector Comment					
Dense berryvines at landward toe.

Looking southeast at dense vegetation at landward toe.

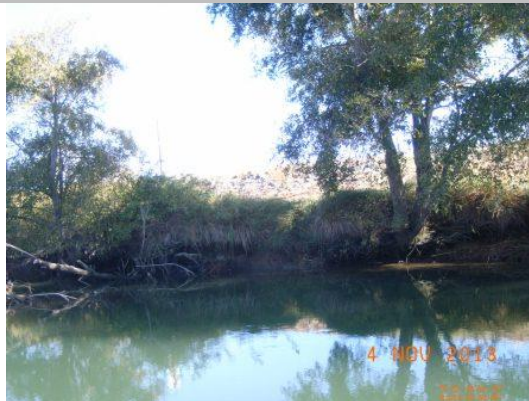
Photo 1 of 1 : SP\_2016\_RD0563\_210\_53\_20160308\_00051.jpg

LM Start	7.53	Rating **	U	Issue No.	53
LM End	7.80	Issue Type +	Ma	Location *	WS
Category	Supplemental			GPS Latitude/Longitude	
				Start	End
Item	2015 USACE Erosion Survey, DRAFT			38.164462 °	38.160888 °
				-121.583092 °	-121.584807 °
DWR ID	DWR_RD0563_01_s _ 2016_53				
Comment Code					
Inspector Comment					
1997 - Pocket erosion at upstream end and into the levee toe under the Alder trees. 2003 - New brush boxes with wattles on bank. 2004 - No brush boxes. 2005 - Site extended from the downstream side of the bridge. Whole bank is vertical. 2010 - Some minor new erosion. 2011 - Site upgraded to CRITICAL. New erosion pockets throughout the site. Sites 4.5, and 4.6 were combined. 2015: Last observed in 2013. [2015 Site ID: GEO_4-5_L]

USACE 2013 Photo #1

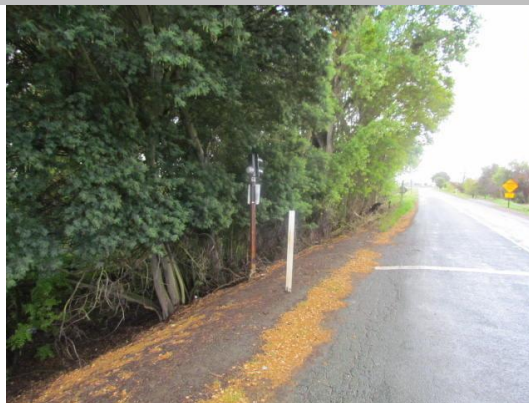
Photo 1 of 1 : SP\_2016\_RD0563\_210\_29\_20160308\_00031.jpg

LM Start	7.74	Rating **	M	Issue No.	29
LM End	7.78	Issue Type +	Ma	Location *	LS
Category	Earthen Levee			GPS Latitude/Longitude	
				Start	End
Item	Trim / Thin Trees			38.161607 °	38.161092 °
				-121.584258 °	-121.584470 °
DWR ID	DWR_RD0563_01_s _ 2012_29				
Comment Code					
T1 : Trim trees to at least five feet above ground level.					
Inspector Comment					
Dense (untrimmed) trees on landward slope.

Looking southeast at dense trees on landward slope and toe.

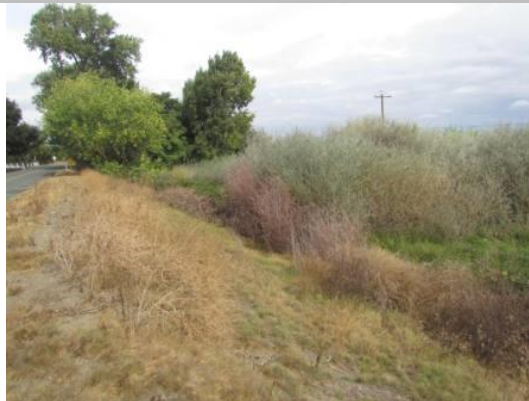
Photo 2 of 5 : SP\_2016\_RD0563\_210\_90\_20160308\_00096.jpg

Looking northeast at dense vegetation on landside toe.

LM Start	7.80	Rating **	U	Issue No.	90 (cont)	
LM End	7.82	Issue Type +	Ma	Location *	LS	
Category	Earthen Levee			GPS Latitude/Longitude		
				Start		End
Item	Vegetation			38.160800 °		38.160487 °
				-121.584598 °		-121.584717 °
DWR ID	DWR_RD0563_01_s_2012_90					
Comment Code						
V2 : Remove the wild growth other than native grasses from the levee slopes.						
Inspector Comment						
Berryvines and willows on landside toe.

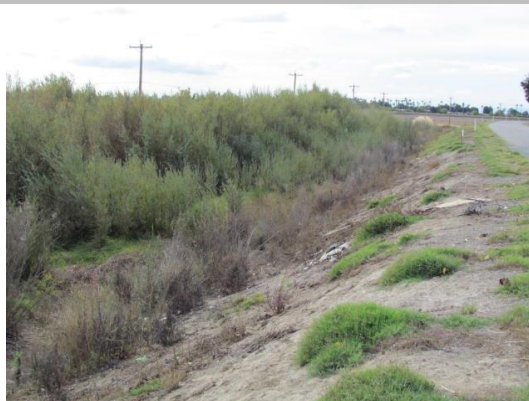
Photo 3 of 5 : SP\_2016\_RD0563\_210\_90\_20160308\_00097.jpg

Looking south at dense vegetation on landside toe. (2012 Fall Inspection)

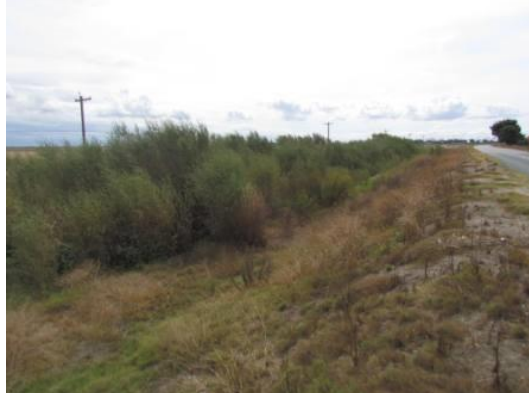
Photo 5 of 5 : SP\_2016\_RD0563\_210\_90\_20160308\_00099.jpg

Looking southwest at dense vegetation on landside toe.

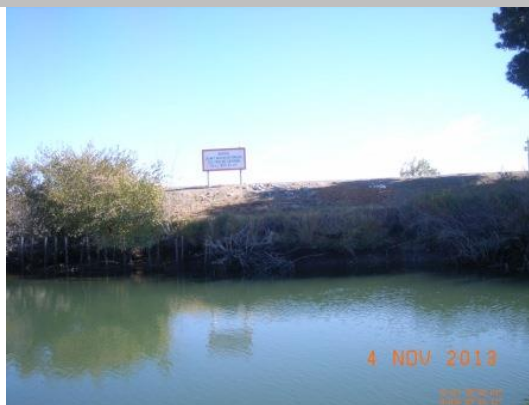
Photo 1 of 1 : SP\_2016\_RD0563\_210\_13\_20160308\_00018.jpg

LM Start	7.85	Rating **	M	Issue No.	13
LM End	8.05	Issue Type +	Ma	Location *	WS
Category	Supplemental			GPS Latitude/Longitude	
				Start	End
Item	2015 USACE Erosion Survey, DRAFT			38.160261 °	38.157625 °
				-121.585056 °	-121.586543 °
DWR ID	DWR_RD0563_01_s_2016_13

Comment Code					
Inspector Comment					
1997 - Pockets of erosion into the levee toe. 1999 - Minor rock riprap and willow bundles place in a couple of spots. 2001 - Staked, low fascine walls at bankline. 2003 - Small unprotected pockets still eroding. 2004 - Numerous brush boxes, some falling apart, some with new bundles. 2005 - Some new brush boxes installed; some boxes are empty. Levee slope and banks still look bad with pocket scallops into the levee slopes. 2011 - Erosion continues and the number of pockets is increasing. 2013 - Some of the downstream end was repaired by the RD. 2015: Last observed in 2013. [2015 Site ID: GEO_4-3_L]

USACE 2013 Photo #1

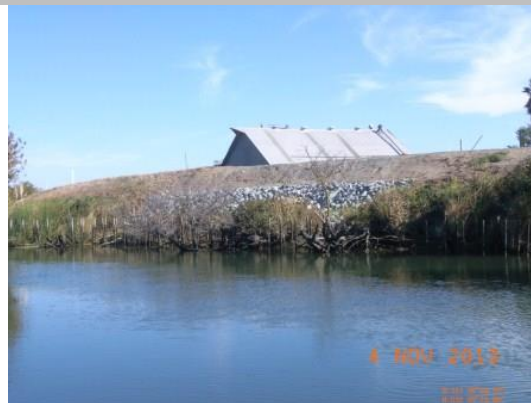
Photo 1 of 1 : SP\_2016\_RD0563\_210\_40\_20160308\_00039.jpg

Comment Code					
Inspector Comment					
1997 - Pockets of erosion into the levee at the water line. Alders are being undercut and rotating out into the channel. Damaged rock at upstream end. 2000 - New minor erosion. 2001 - Staked low fascine walls at bankline. 2002 - New "Brush Boxes" along the bank toe. 2003 - New erosion pockets in the middle of the site. 2005 - Some new bundles in the brush boxes. 2011 - Site upgraded to CRITICAL. Significant new erosion. Sites 3.6, 3.7, 3.71, and 4.0 were combined. 2012 - Rock has been placed in some of the erosion pockets since last year, however site remains critical. 2013 - Site no longer critical. The worst pockets were filled with rock by the local RD. 2015: Last observed in 2013. [2015 Site ID: GEO_3-8_L]

USACE 2013 Photo #1

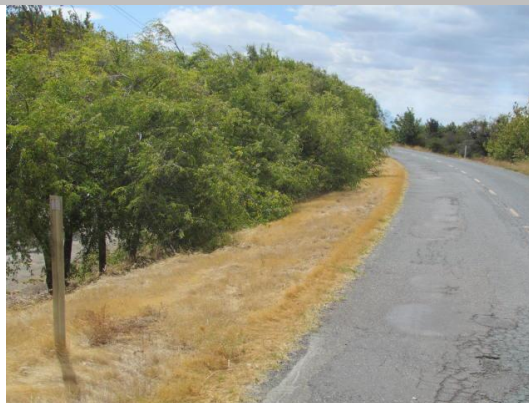
Photo 1 of 1 : SP\_2016\_RD0563\_210\_31\_20160308\_00032.jpg

LM Start	8.38	Rating **	U	Issue No.	31
LM End	8.41	Issue Type +	Ma	Location *	LS
Category	Earthen Levee			GPS Latitude/Longitude	
				Start	End
Item	Trim / Thin Trees			38.155974 °	38.155543 °
				-121.591452 °	-121.591595 °
DWR ID	DWR_RD0563_01_s_2012_31				
Comment Code					
T1 : Trim trees to at least five feet above ground level.					
Inspector Comment

Looking southeast at untrimmed trees on landward slope and toe.

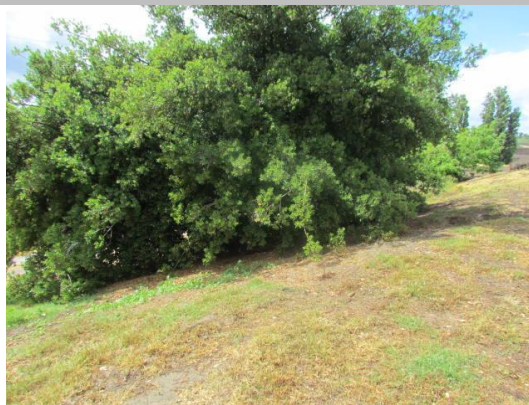
Photo 1 of 1 : SP\_2016\_RD0563\_210\_98\_20160308\_00108.jpg

LM Start	9.28	Rating **	U	Issue No.	98
LM End	9.28	Issue Type +	Ma	Location *	LS
Category	Earthen Levee			GPS Latitude/Longitude	
				Start	End
Item	Trim / Thin Trees			38.145825 °	38.145825 °
				-121.588807 °	-121.588807 °
DWR ID	DWR_RD0563_01_s_2013_98				
Comment Code					
T1 : Trim trees to at least five feet above ground level.					
Inspector Comment

Looking southeast at untrimmed trees on landward slope.

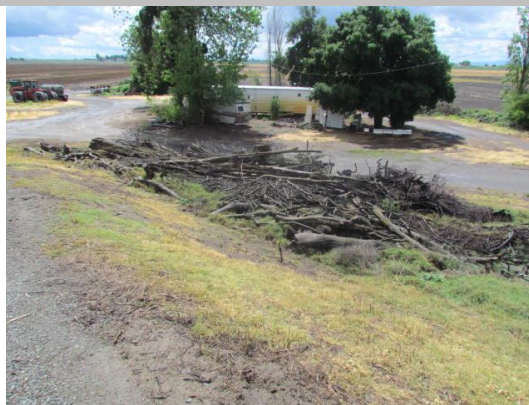
Photo 1 of 2 : SP\_2016\_RD0563\_210\_73\_20160308\_00065.jpg

LM Start	9.33	Rating **	U	Issue No.	73
LM End	9.33	Issue Type +	Ma	Location *	LS
Category	Earthen Levee			GPS Latitude/Longitude	
				Start	End
Item	Encroachments			38.145957 °	38.145957 °
				-121.589653 °	-121.589653 °
DWR ID	DWR_RD0563_01_s_2012_73				
Comment Code					
PR : Prunings					
Inspector Comment					
Large pruning pile on landward toe.

Looking east at prunings at landward toe. (Spring 2015)

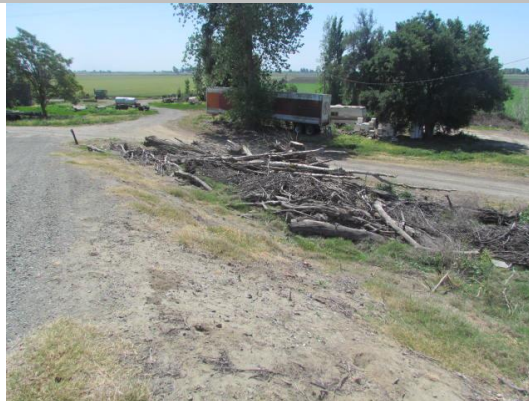
Photo 2 of 2 : SP\_2016\_RD0563\_210\_73\_20160308\_00066.jpg

LM Start	9.33	Rating **	U	Issue No.	73 (cont)	
LM End	9.33	Issue Type +	Ma	Location *	LS	
Category	Earthen Levee			GPS Latitude/Longitude		
				Start		End
Item	Encroachments			38.145957 °		38.145957 °
				-121.589653 °		-121.589653 °
DWR ID	DWR_RD0563_01_s _ 2012_73					
Comment Code						
PR : Prunings						
Inspector Comment						
Large pruning pile on landward toe.

Looking east at prunings on landward slope. (Spring 2013)

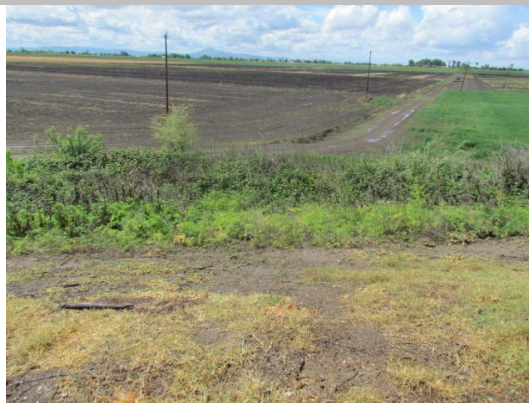
Photo 1 of 1 : SP\_2016\_RD0563\_210\_769\_20160308\_00143.jpg

LM Start	9.36	Rating **	U	Issue No.	769
LM End	9.43	Issue Type +	Ma	Location *	LS
Category	Earthen Levee			GPS Latitude/Longitude	
				Start	End
Item	Vegetation			38.146276 °	38.147034 °
				-121.590189 °	-121.590907 °
DWR ID	DWR_RD0563_01_s _ 2015_769				
Comment Code					
V2 : Remove the wild growth other than native grasses from the levee slopes.					
Inspector Comment

Looking east at dense vegetation at landward toe. (Spring 2015)

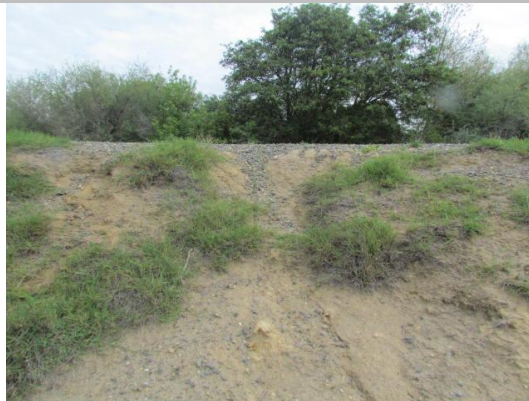
Photo 1 of 2 : SP\_2016\_RD0563\_210\_99\_20160308\_00109.jpg

LM Start	9.65	Rating **	M	Issue No.	99
LM End	9.65	Issue Type +	Ma	Location *	LS
Category	Earthen Levee			GPS Latitude/Longitude	
				Start	End
Item	Erosion / Bank Caving			38.149905 °	38.149905 °
				-121.592910 °	-121.592910 °
DWR ID	DWR_RD0563_01_s _ 2013_99				
Comment Code					
E1 : Note and monitor erosion site.					
Inspector Comment					
Finger erosion on landward shoulder and slope.

Looking west at minor erosion on landward shoulder and slope.

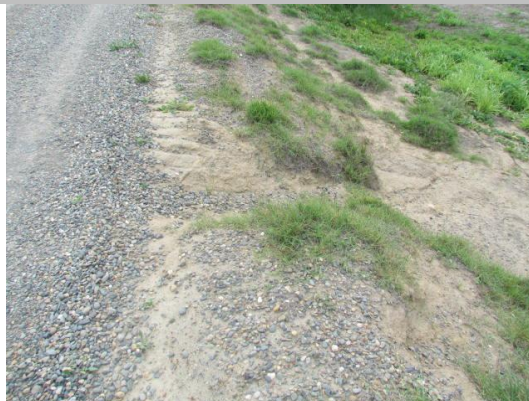
Photo 2 of 2 : SP\_2016\_RD0563\_210\_99\_20160308\_00110.jpg

LM Start	9.65	Rating **	M	Issue No.	99 (cont)
LM End	9.65	Issue Type +	Ma	Location *	LS

Looking north at minor erosion on landward shoulder and slope.

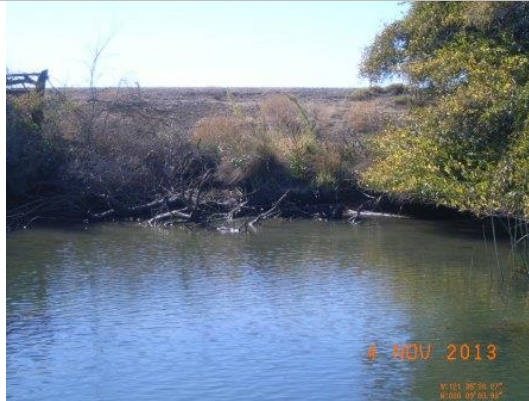
Photo 1 of 1 : SP\_2016\_RD0563\_210\_41\_20160308\_00040.jpg

LM Start	9.73	Rating **	M	Issue No.	41
LM End	9.90	Issue Type +	Ma	Location *	WS
Category	Supplemental			GPS Latitude/Longitude	
				Start	End
Item	2015 USACE Erosion Survey, DRAFT			38.150820 °	38.150647 °
				-121.593650 °	-121.596858 °
DWR ID	DWR_RD0563_01_s _ 2016_41				
Comment Code					
Inspector Comment					
1997 - Erosion pockets into the toe of the levee. 2001 - Staked low fascine walls at the bankline. 2004 - Numerous "Brush Boxes." 2005 - Some new bundles in the brush boxes. 2012 - Site extended downstream to account for new bank sloughing. 2013 - Some rock added to the upstream end by the local RD. 2015: Last observed in 2013. [2015 Site ID: GEO_2-5_L]

USACE 2013 Photo #1

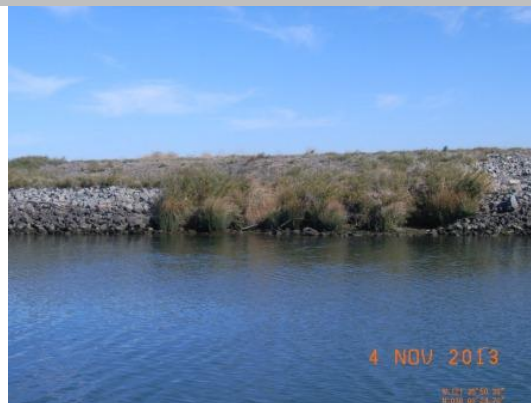
Photo 1 of 1 : SP\_2016\_RD0563\_210\_43\_20160308\_00042.jpg

LM Start	10.45	Rating **	M	Issue No.	43
LM End	10.74	Issue Type +	Ma	Location *	WS
Category	Supplemental			GPS Latitude/Longitude	
				Start	End
Item	2015 USACE Erosion Survey, DRAFT			38.143519 °	38.139918 °
				-121.599677 °	-121.596986 °
DWR ID	DWR_RD0563_01_s _ 2016_43				
Comment Code					
Inspector Comment					
1997 - Old damaged rock riprap along the toe. 1999 - Downstream end (400 ft) repaired with rock. 2002 - New rock/concrete rubble section on the downstream end. 2004 - Small pocket repairs at the downstream end. 2005 - Some new bundles in the brush boxes. 2012 - Some rock has been placed in last year. 2015: Last observed in 2013. [2015 Site ID: GEO_1-7_L]

USACE 2013 Photo #1

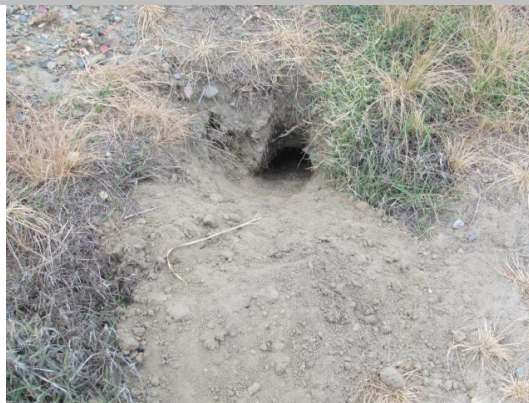
Photo 1 of 4 : SP\_2016\_RD0563\_210\_77\_20160330\_00253.jpg

LM Start	10.59	Rating **	U	Issue No.	77
LM End	10.64	Issue Type +	Ma	Location *	LS
Category	Earthen Levee			GPS Latitude/Longitude	
				Start	End
Item	Animal Control			38.141957 °	38.141362 °
				-121.598058 °	-121.597598 °
DWR ID	DWR_RD0563_01_s_2012_77				
Comment Code					
A1 : Exterminate rodents and backfill and compact or grout burrows.					
Inspector Comment					
Several rodent holes and rodents noted at this site.

Looking at typical rodent hole on landward slope. (Spring 2016)

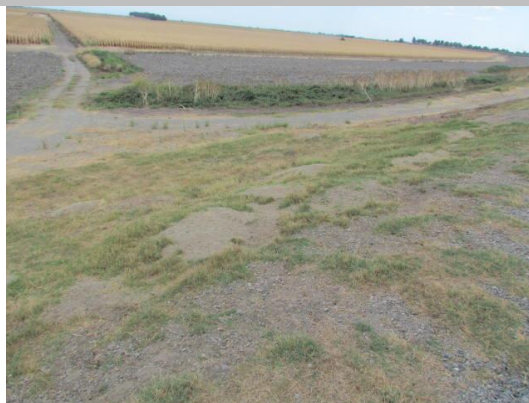
Photo 2 of 4 : SP\_2016\_RD0563\_210\_77\_20160308\_00074.jpg

Looking southeast at several rodent holes on landward slope.

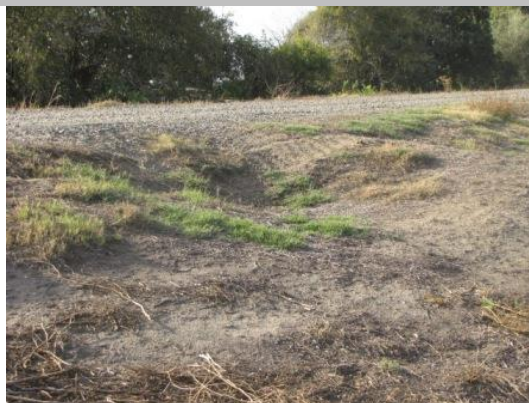
Photo 4 of 4 : SP\_2016\_RD0563\_210\_76\_20160308\_00073.jpg

LM Start	10.59	Rating **	M	Issue No.	76 (cont)	
LM End	10.59	Issue Type +	Ma	Location *	LS	
Category	Earthen Levee			GPS Latitude/Longitude		
				Start		End
Item	Slope Stability			38.141940 °		38.141940 °
				-121.598033 °		-121.598033 °
DWR ID	DWR_RD0563_01_s_2012_76					
Comment Code						
S1 : Repair slope instability.						
Inspector Comment						
Deep depression on landside shoulder and slope; possible pipe collapse.

Looking west at depression on landside shoulder and slope.

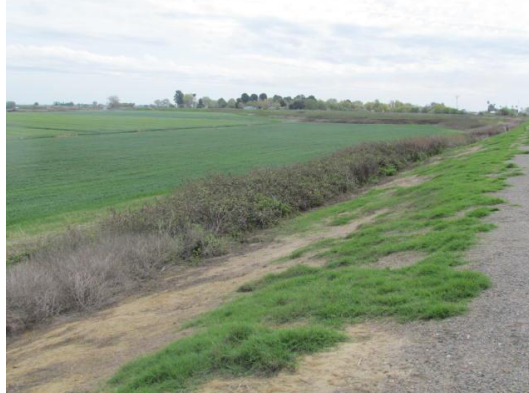
Photo 2 of 3 : SP\_2016\_RD0563\_210\_100\_20160308\_00112.jpg

LM Start	10.67	Rating **	U	Issue No.	100 (cont)	
LM End	10.81	Issue Type +	Ma	Location *	LS	
Category	Earthen Levee			GPS Latitude/Longitude		
				Start		End
Item	Vegetation			38.140886 °		38.139079 °
				-121.597280 °		-121.596214 °
DWR ID	DWR_RD0563_01_s _ 2013_100					
Comment Code						
V2 : Remove the wild growth other than native grasses from the levee slopes.						
Inspector Comment						
Wild rose or grape vines on landward slope and toe.

Looking south at dense vegetation at landward toe. (Fall 2014)

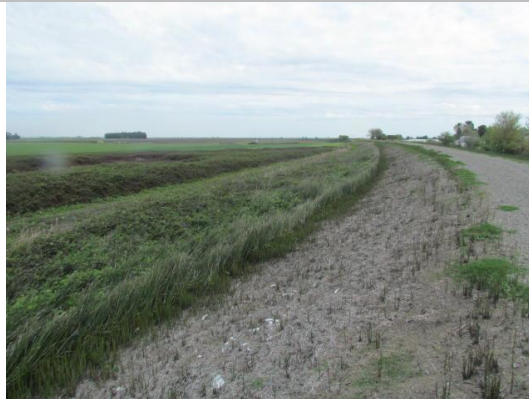
Photo 3 of 3 : SP\_2016\_RD0563\_210\_100\_20160308\_00113.jpg

Looking south at additional dense vegetation at landward toe.

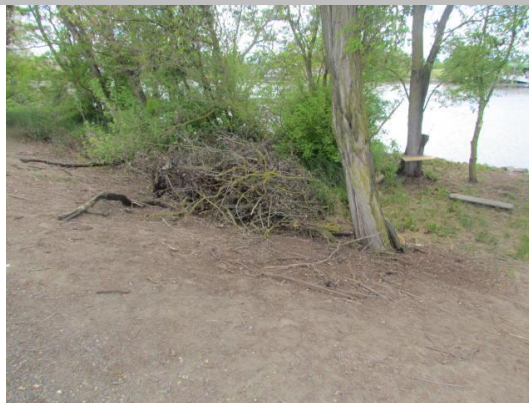
Photo 1 of 1 : SP\_2016\_RD0563\_210\_167\_20160330\_00254.jpg

LM Start	11.24	Rating **	M	Issue No.	167
LM End	11.24	Issue Type +	Ma	Location *	WS
Category	Earthen Levee			GPS Latitude/Longitude	
				Start	End
Item	Encroachments			38.134224 °	38.134224 °
				-121.591406 °	-121.591406 °
DWR ID	DWR_RD0563_01_s _ 2016_167				
Comment Code					
PR : Prunings					
Inspector Comment					
Prunings on waterward slope.

Looking west at prunings on waterward slope.

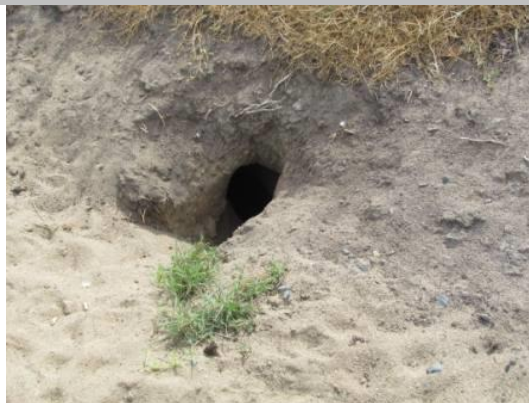
Photo 2 of 3 : SP\_2016\_RD0563\_210\_91\_20160308\_00101.jpg

LM Start	11.45	Rating **	M	Issue No.	91 (cont)	
LM End	11.45	Issue Type +	Ma	Location *	LS	
Category	Earthen Levee			GPS Latitude/Longitude		
				Start		End
Item	Animal Control			38.131943 °		38.131943 °
				-121.588912 °		-121.588912 °
DWR ID	DWR_RD0563_01_s_2012_91					
Comment Code						
A3 : No rodents visible, but rodent burrows visible; need to backfill and compact or grout burrows.						
Inspector Comment

Looking west at rodent hole on landside slope.

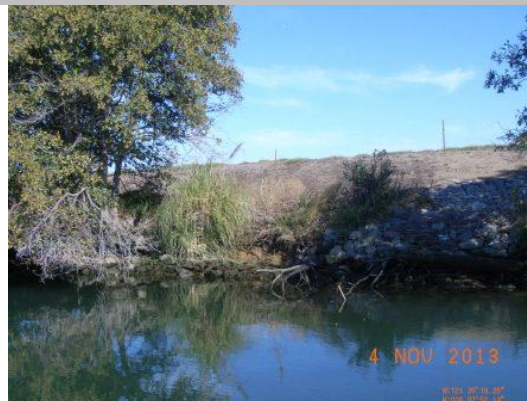
Photo 1 of 1 : SP\_2016\_RD0563\_210\_42\_20160308\_00041.jpg

Comment Code					
Inspector Comment					
1997 - Erosion pockets into the levee toe. 1999 - Some small pockets fixed with rock riprap. 2002 - New "brush boxes" along the bank toe. 2005 - Brush boxes are empty. Some pockets are filled with new stone. 2006 - Some new rock at the downstream end (~100 ft long). Several small pockets of new rock in scallops. Brush boxes in poor to fair condition. 2010 - Site looks a little worse, some toe rock but still has erosion scars at lower to mid slope. 2011 - Site upgraded to CRITICAL. Significant new erosion. Erosion scallops are vertical and almost the height of the levee. 2012 - Rock has been placed in some of the erosion scallops and therefore the site is no longer critical. 2013 - Site shortened site. The downstream half of site was repaired by RD. Pipe no longer in site limits. 2015: Last observed in 2013. [2015 Site ID: GEO 0-3 L]

USACE 2013 Photo #1

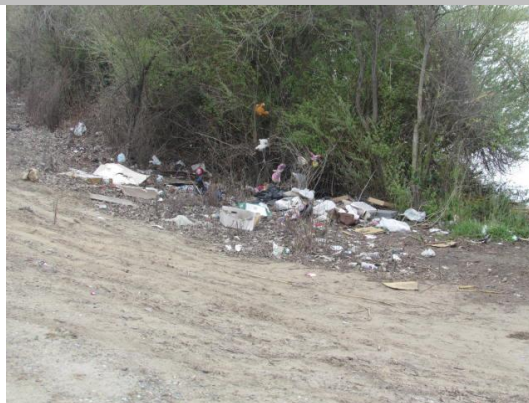
Photo 1 of 1 : SP\_2016\_RD0563\_210\_107\_20160308\_00117.jpg

LM Start	12.03	Rating **	A/W	Issue No.	107
LM End	12.03	Issue Type +	Ma	Location *	WS
Category	Earthen Levee			GPS Latitude/Longitude	
				Start	End
Item	Encroachments			38.130776 °	38.130776 °
				-121.579063 °	-121.579063 °
DWR ID	DWR_RD0563_01_f_2013_107				
Comment Code					
GA : Garbage					
Inspector Comment

Looking southwest at garbage at waterward slope and toe.
